# COOPER'S POINT CONVEYANCE IMPROVEMENTS, CIRCULATION STUDY, DESIGN, AND PERMITTING

June 26, 2024

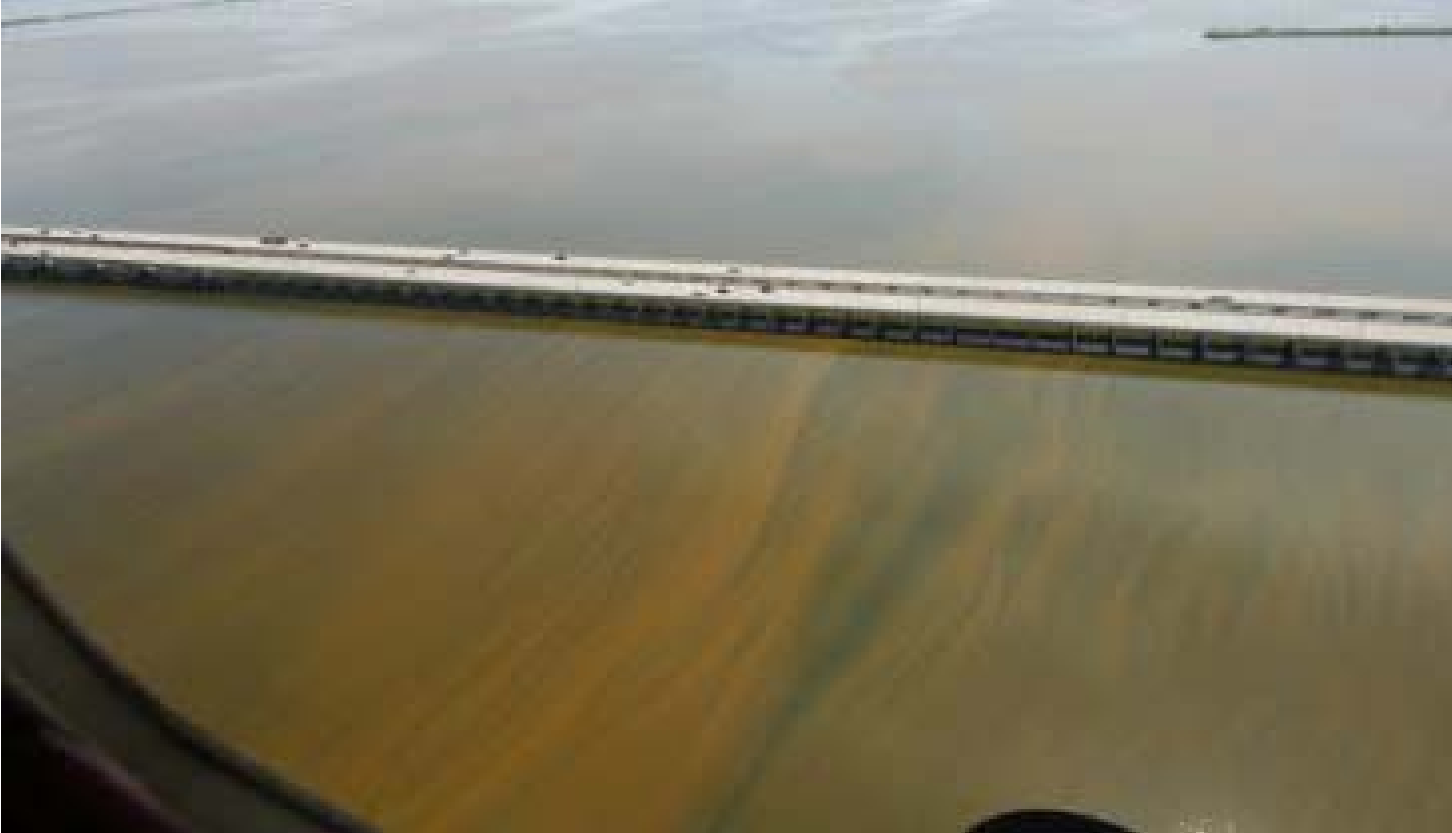
2009 *Pyrodinium* bloom

- Annual blooms of *P. bahamense* since 2000
  - Blooms are concentrated the most in Cooper's Point
- Strategies to reduce blooms
  - Increase flushing
  - Reduce residence time
  - Muck removal

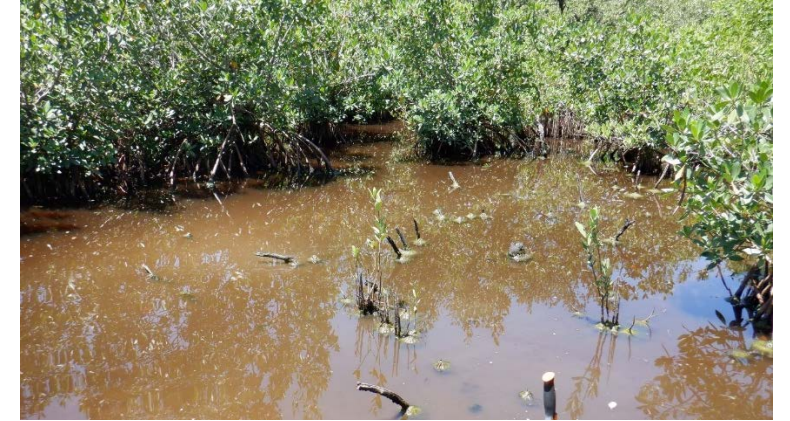
Poor Water Quality

- The threshold for chlorophyll-a is 8.5
  - 2017 – 9.7 - 13.8
  - 2018 – 11.3 – 16.8
  - 2019 - 11.2 – 14.8
- Only region of Old Tampa Bay that consistently does not meet threshold

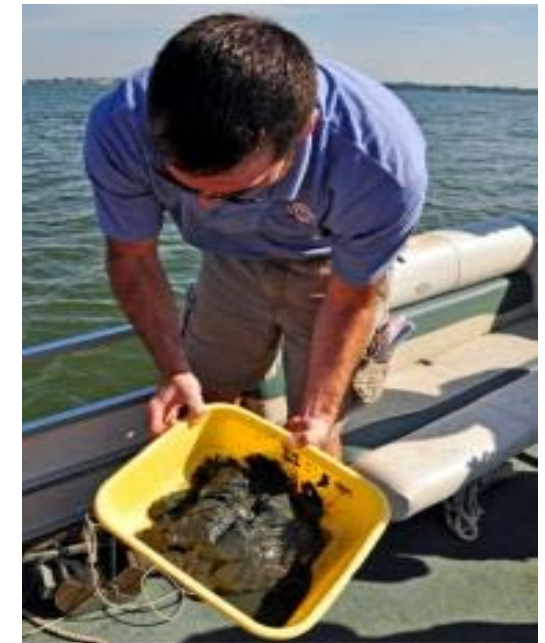
Safety Harbor  
Sediment Muck

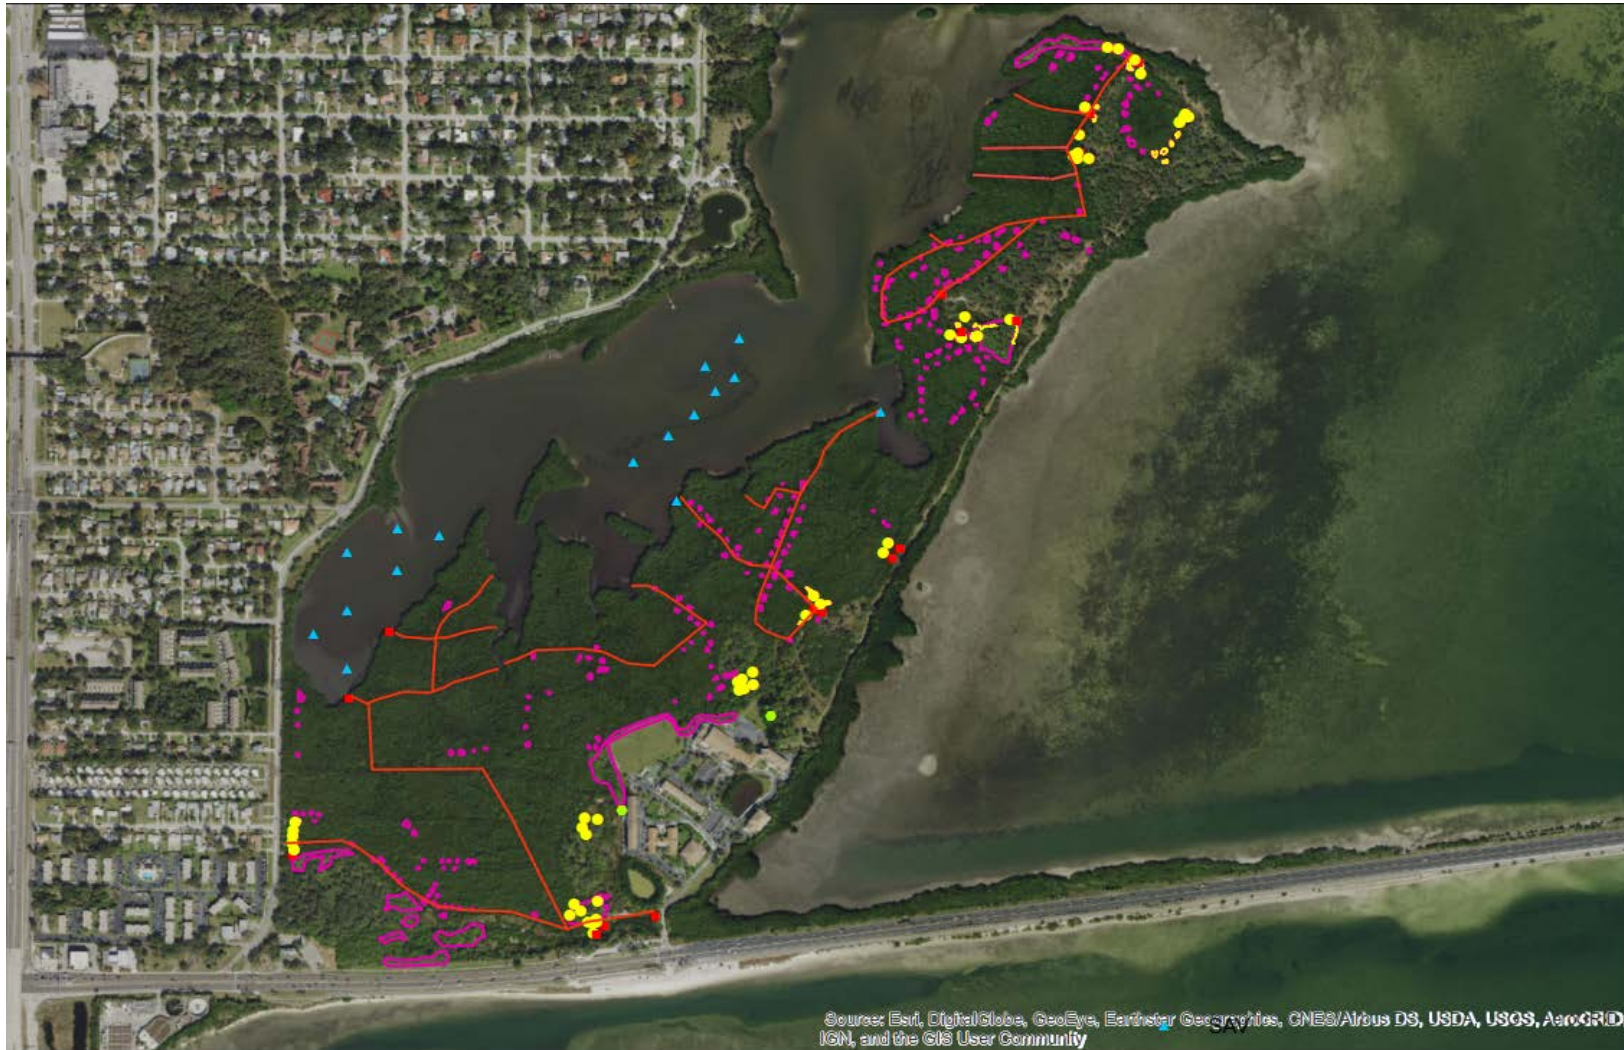
Mosquito Ditching and Spoil Piles

- 38 spoil piles field verified during survey
- Piles range from 0.003 and 1.12 acres
- 60% of piles contained Brazilian pepper
- Range from 10 in – 4 feet in elevation
- 214 spoil piles aurally interpreted
- Total of 4.17 acres across site

- 11 mosquito ditches field verified
- Ranged from 14-in to 80-in in width
- Ranged from 10 in to 5 feet in depth
- Many with obstructions limiting flushing

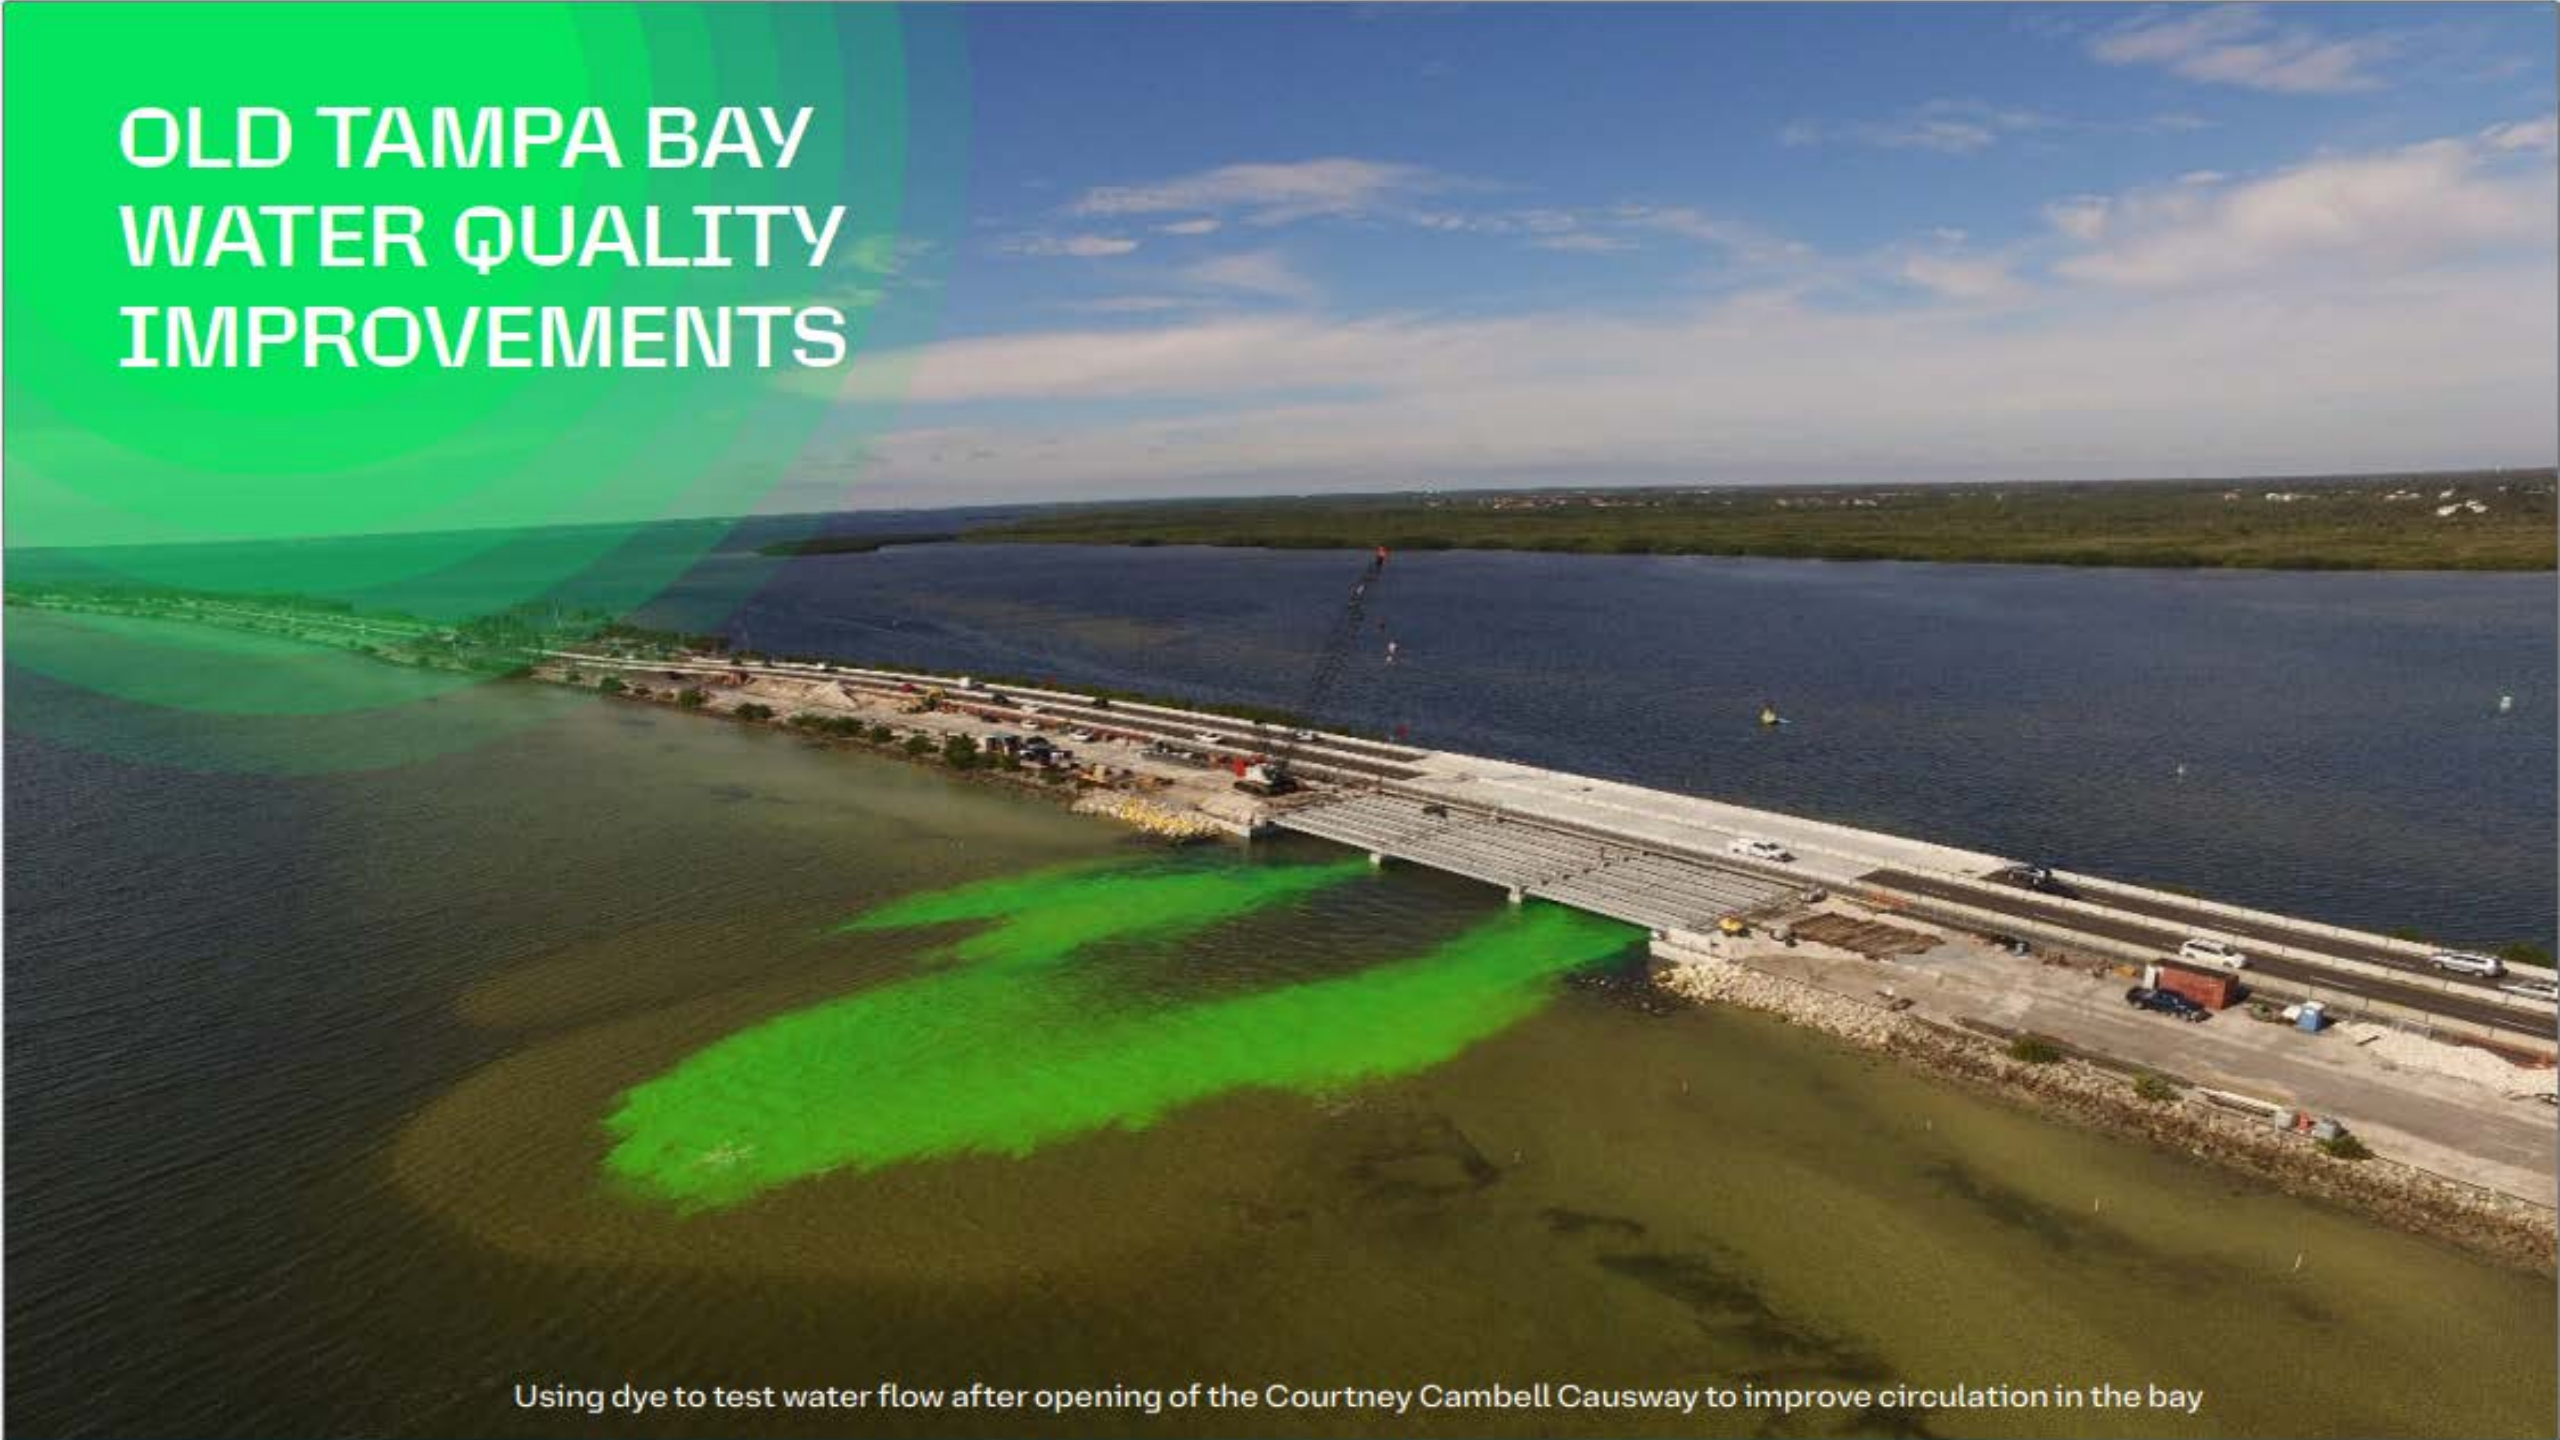
Using dye to test water flow after opening of the Courtney Cambell Causway to improve circulation in the bay

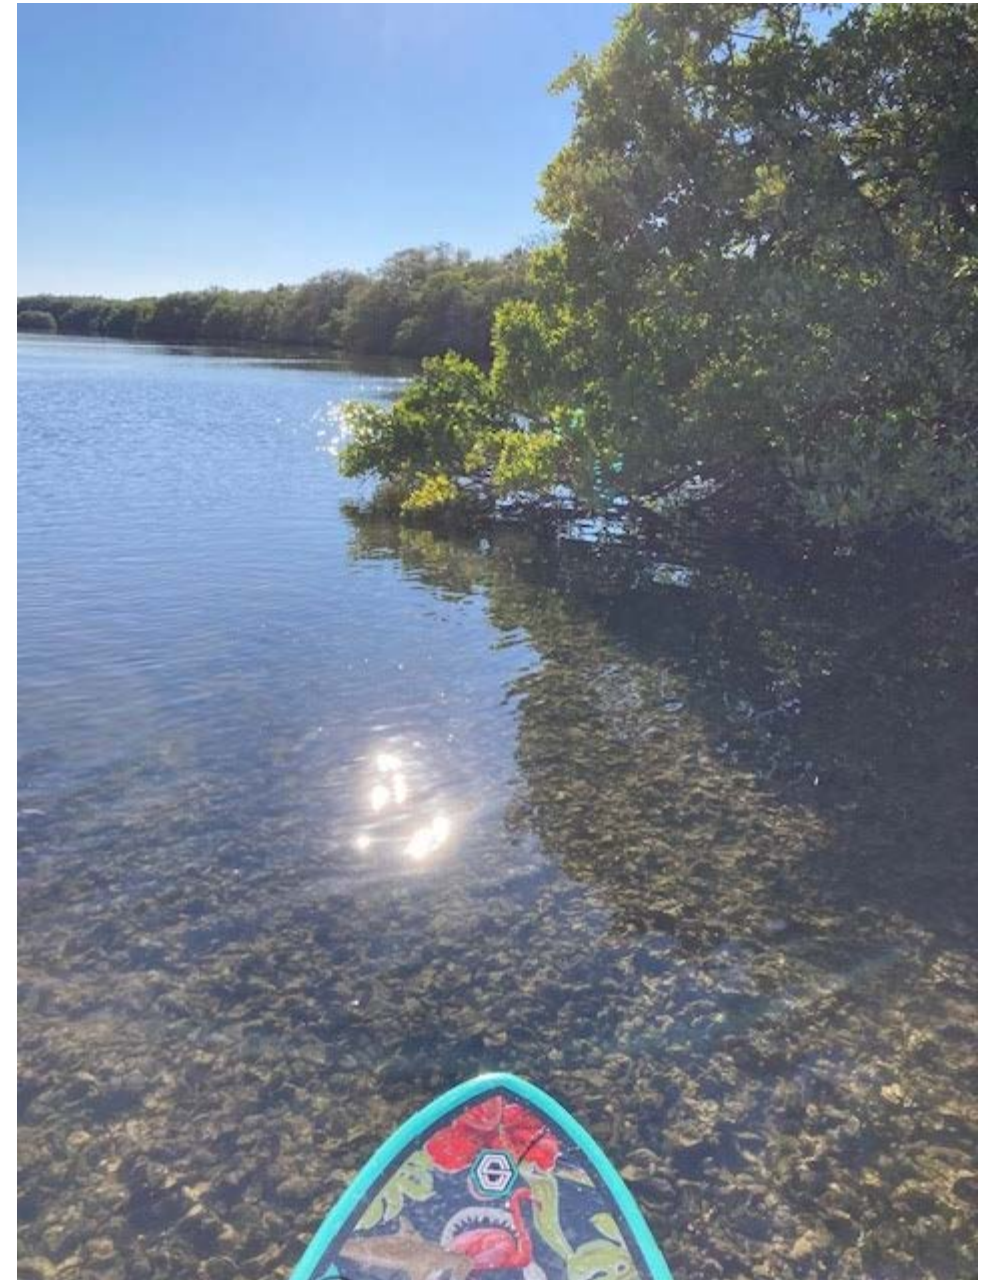
- Delft3D model – simulates tidal circulation, freshwater inflows, and constituent transport
  - Model domain encompasses Old Tampa Bay, with increasing spatial detail within Cooper's Bayou
  - Bathymetry from previous model as well as USGS elevation DEM if necessary
  - Tidal boundary at Gandy Bridge
  - Freshwater inflows within Bayou
- Conservative tracer to quantify residence time
- Residence time defined as the time to reach 10% of initial concentration of tracer (i.e., a 90% reduction)
- Compare design alternatives to base conditions to gauge flushing improvement

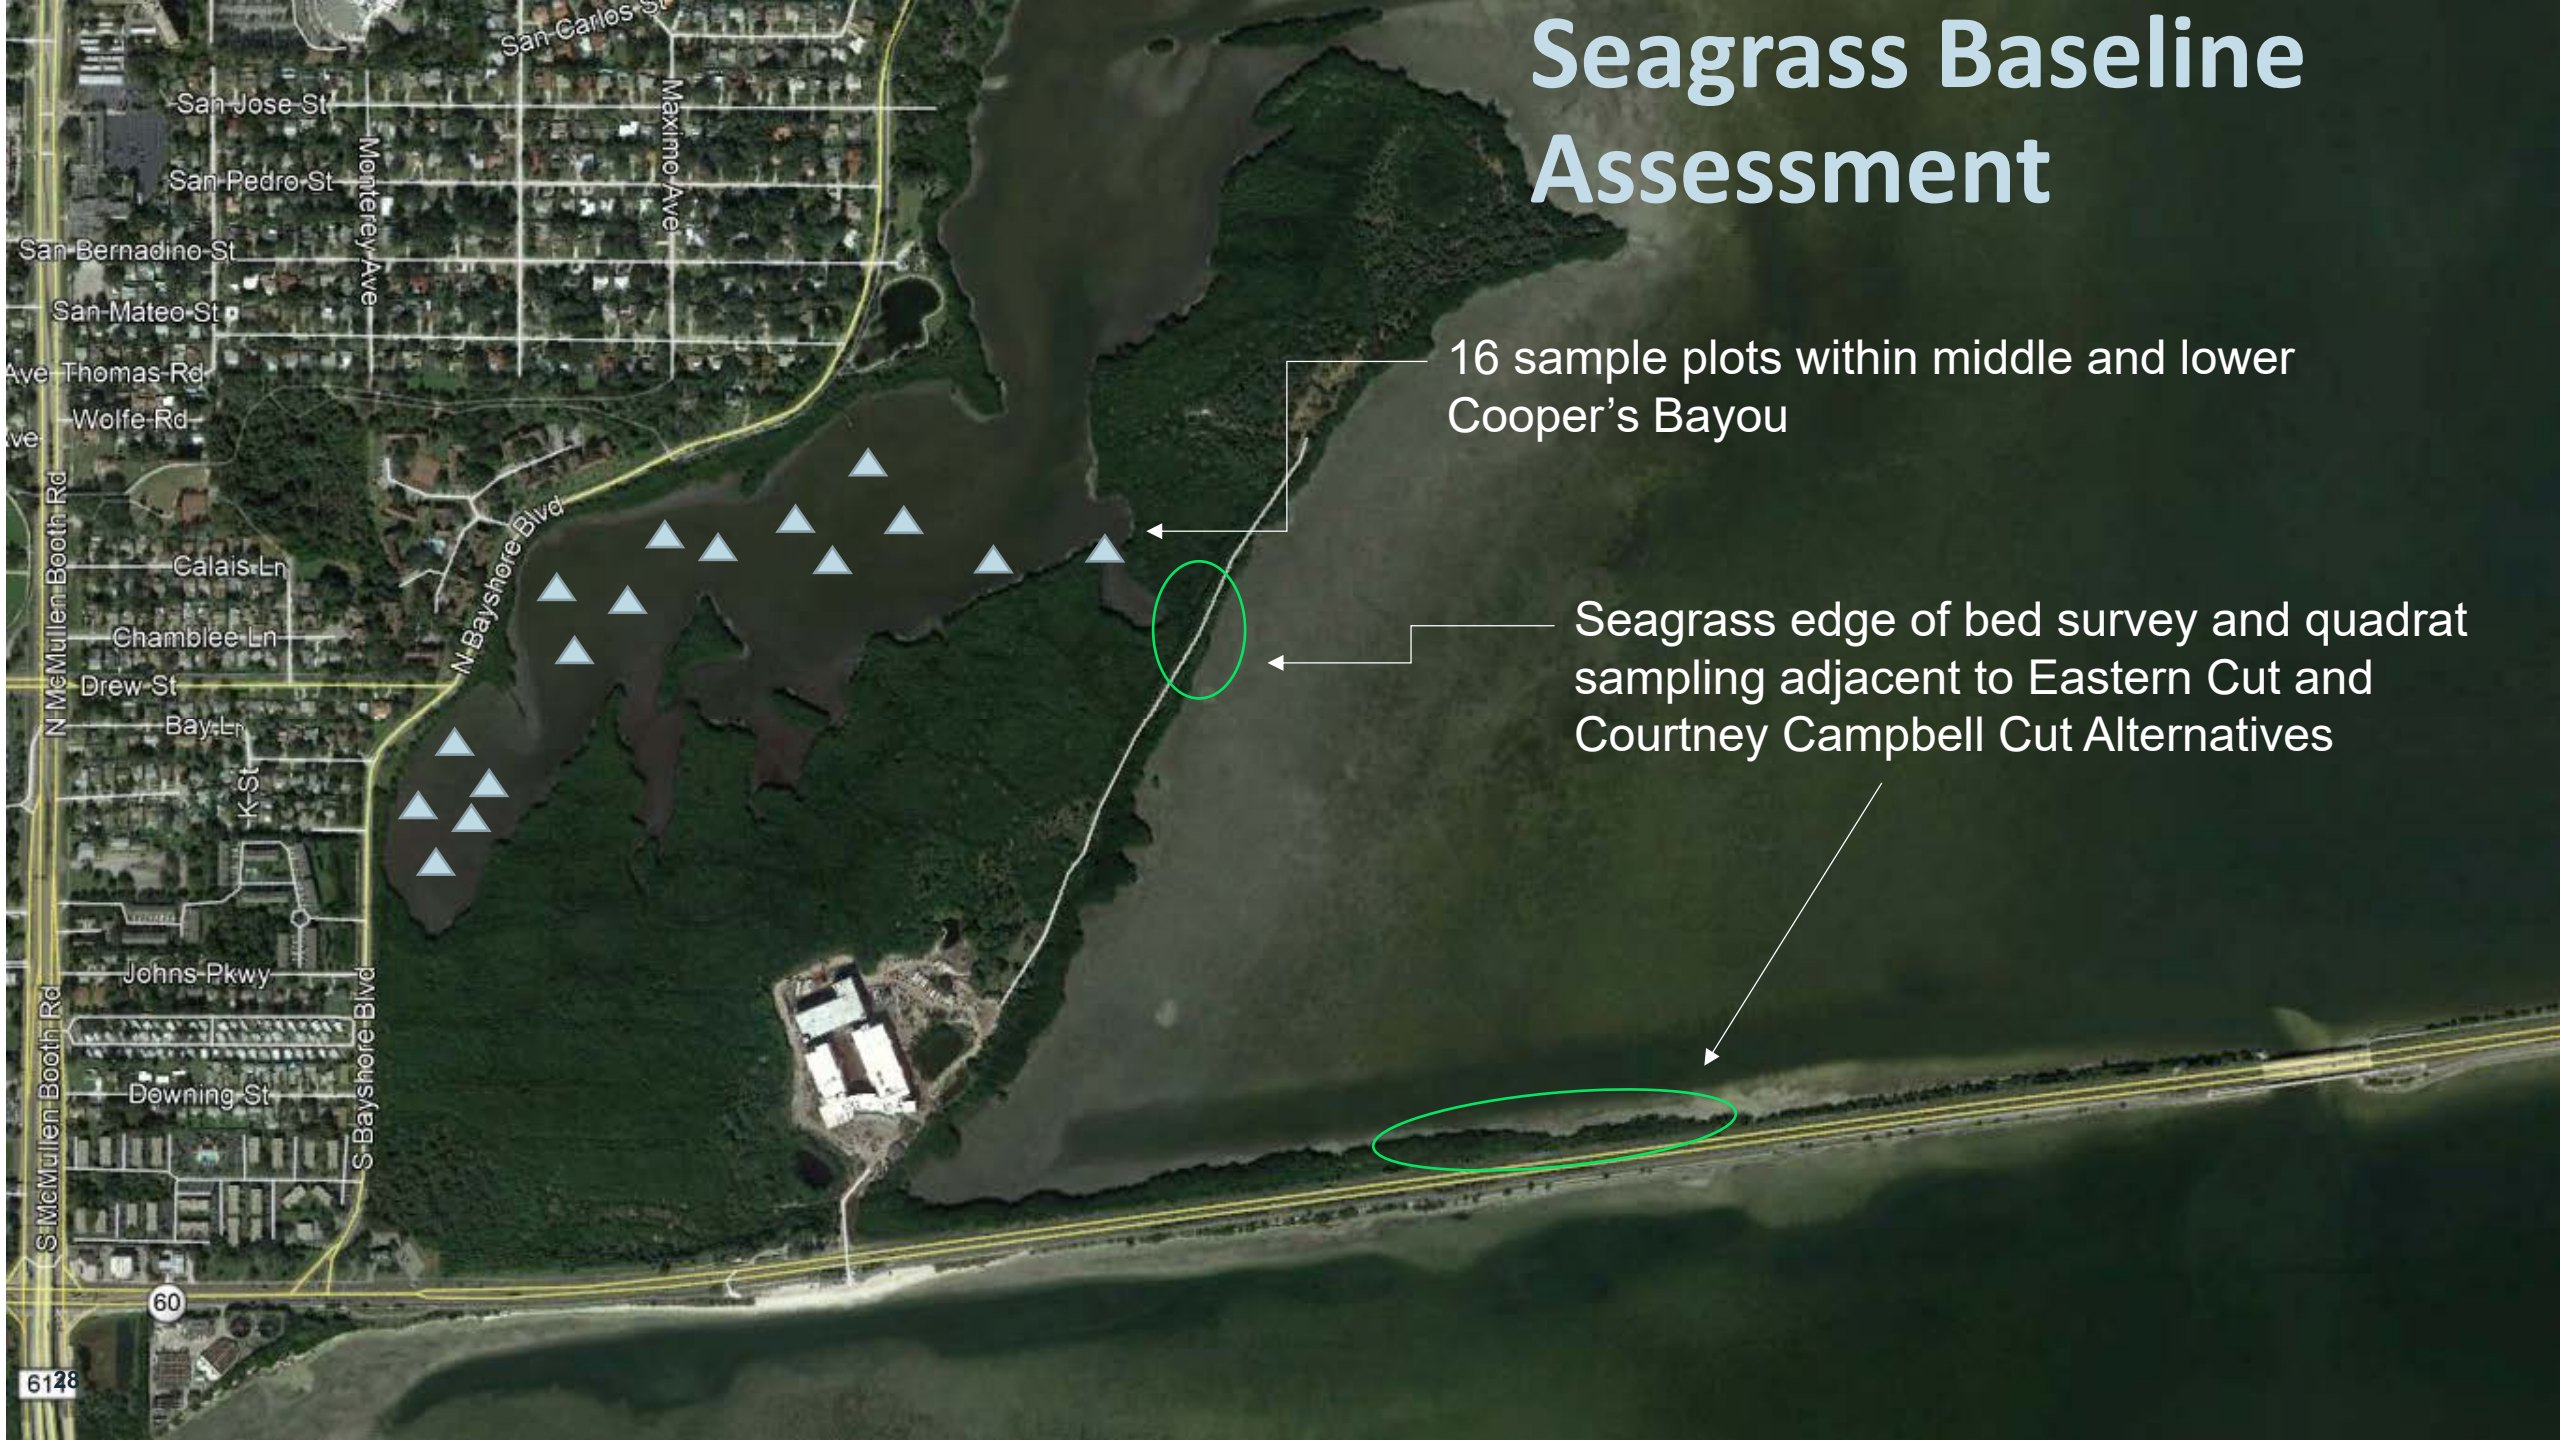
16 sample plots within middle and lower Cooper's Bayou

Seagrass edge of bed survey and quadrat sampling adjacent to Eastern Cut and Courtney Campbell Cut Alternatives
