## Geotechnical Challenges and Foundation Innovations

# HMGMA (Hyundai Motor Group Metaplant America) Project

Ellabell, Georgia

Guoming Lin, Ph.D., G.E., BC.GE  
Vice President/Senior Consultant

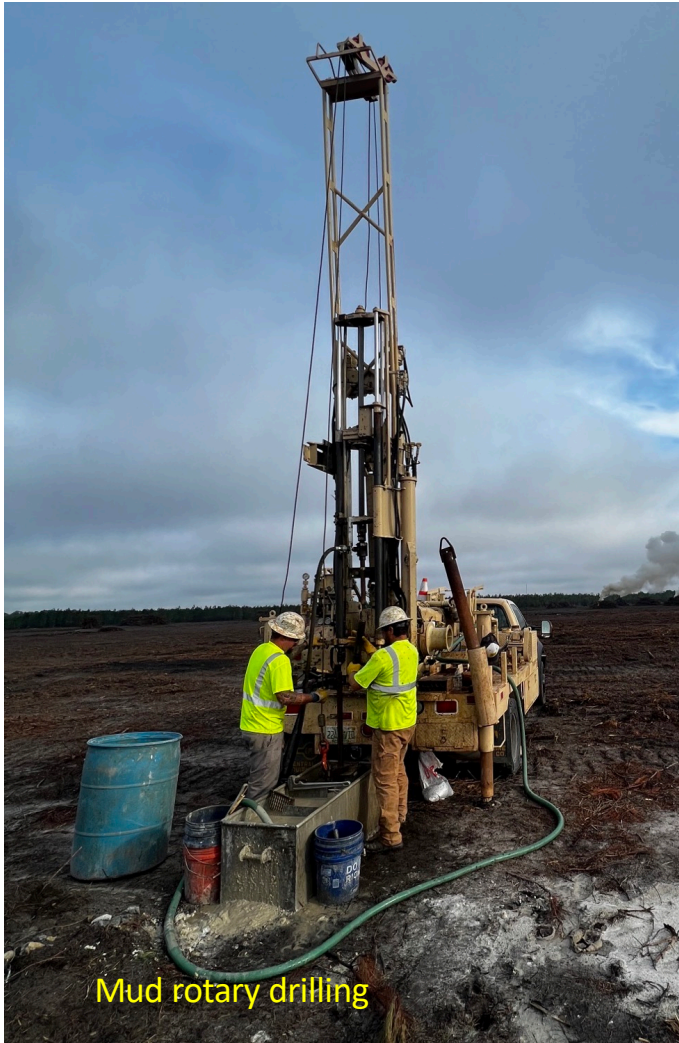
Mud rotary drilling

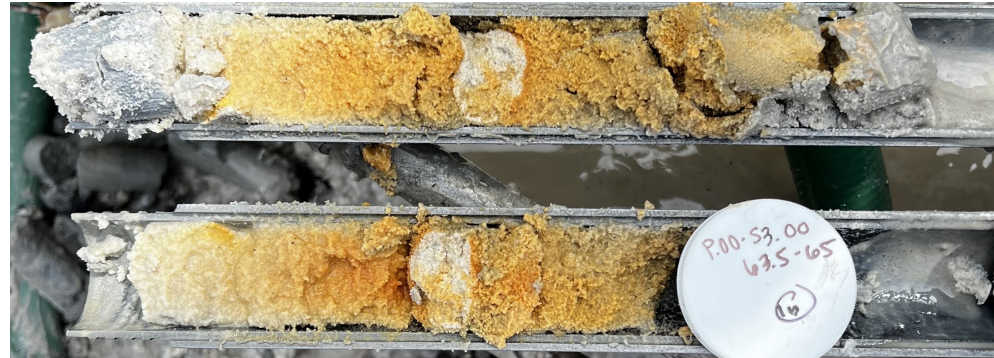
Light brown and orange fine to coarse grained sand with silt (SP-SM)

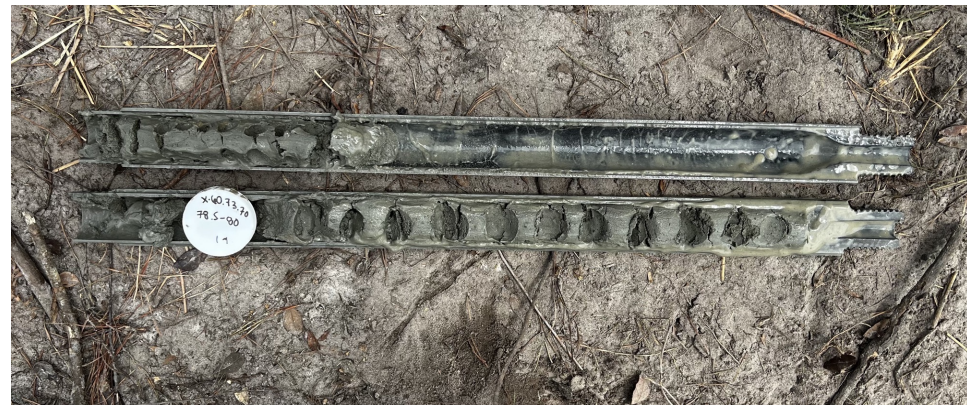
Greenish-gray sandy silt (ML)

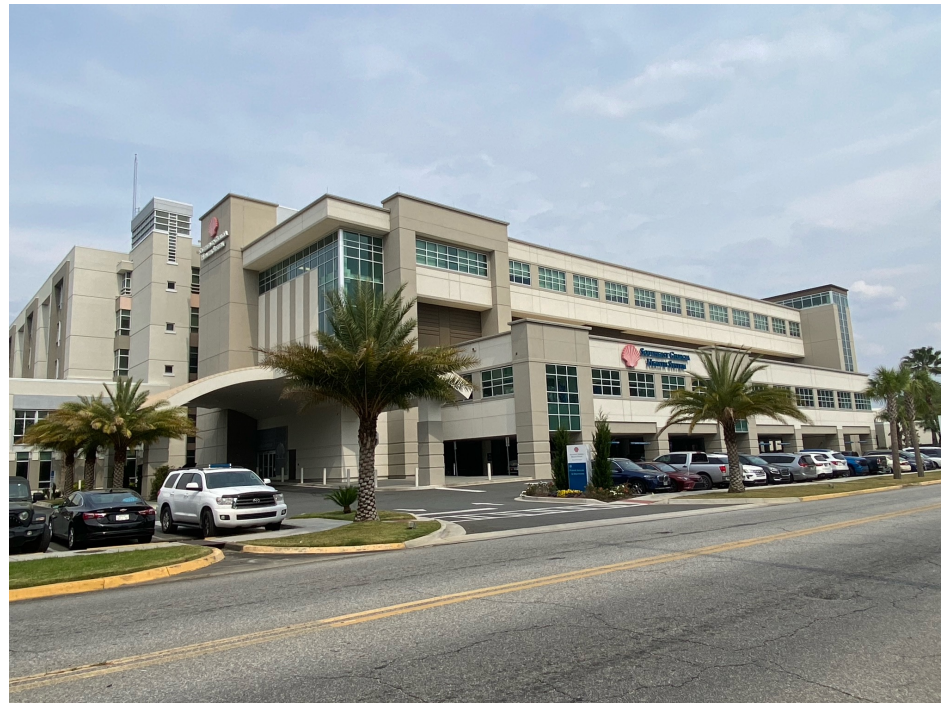
## Southeast Georgia Hospital Thermal Integrity Profiling (TIP)

TIP Results were confirmed

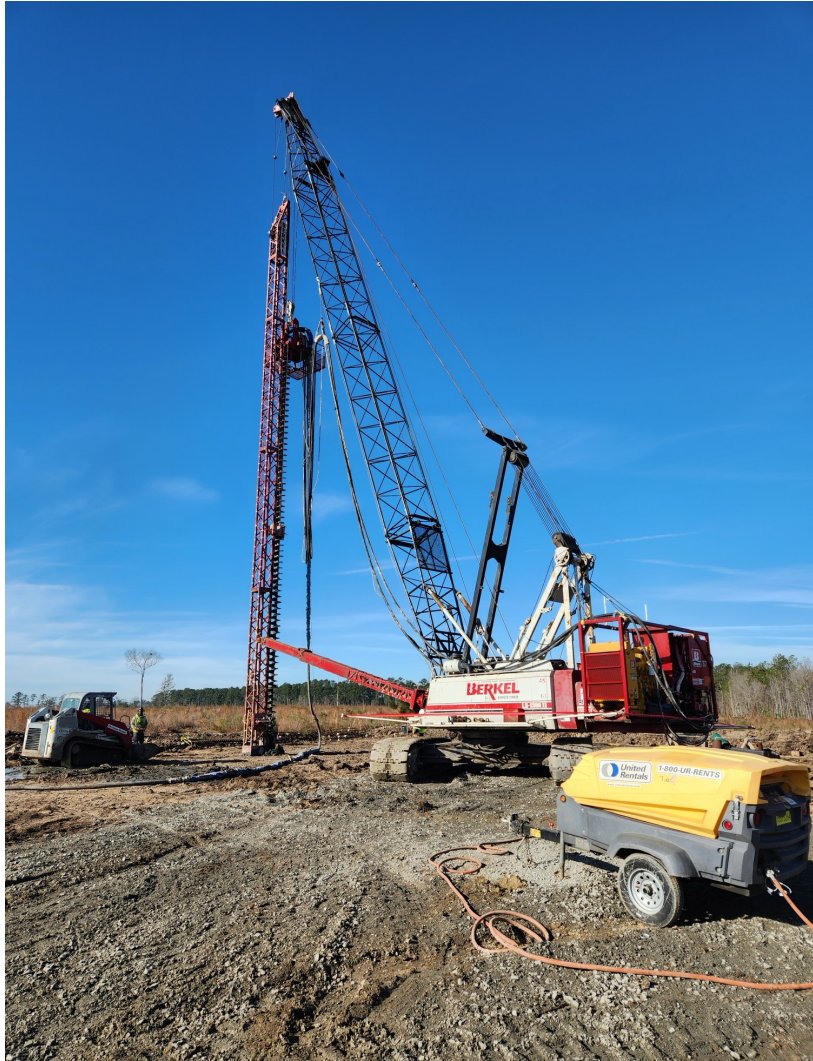
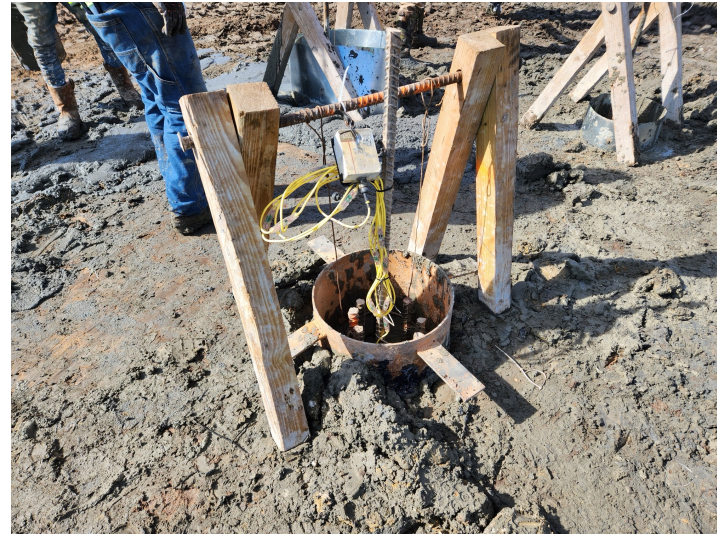
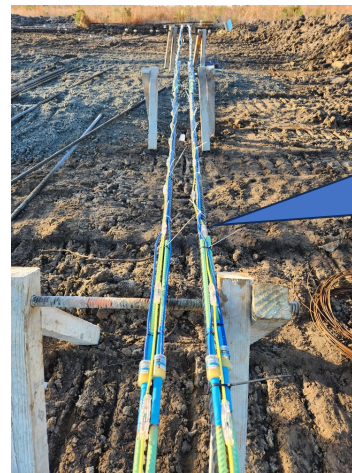
Measured circumference  
Back-calculated diameter=16.23"

Strain Gages

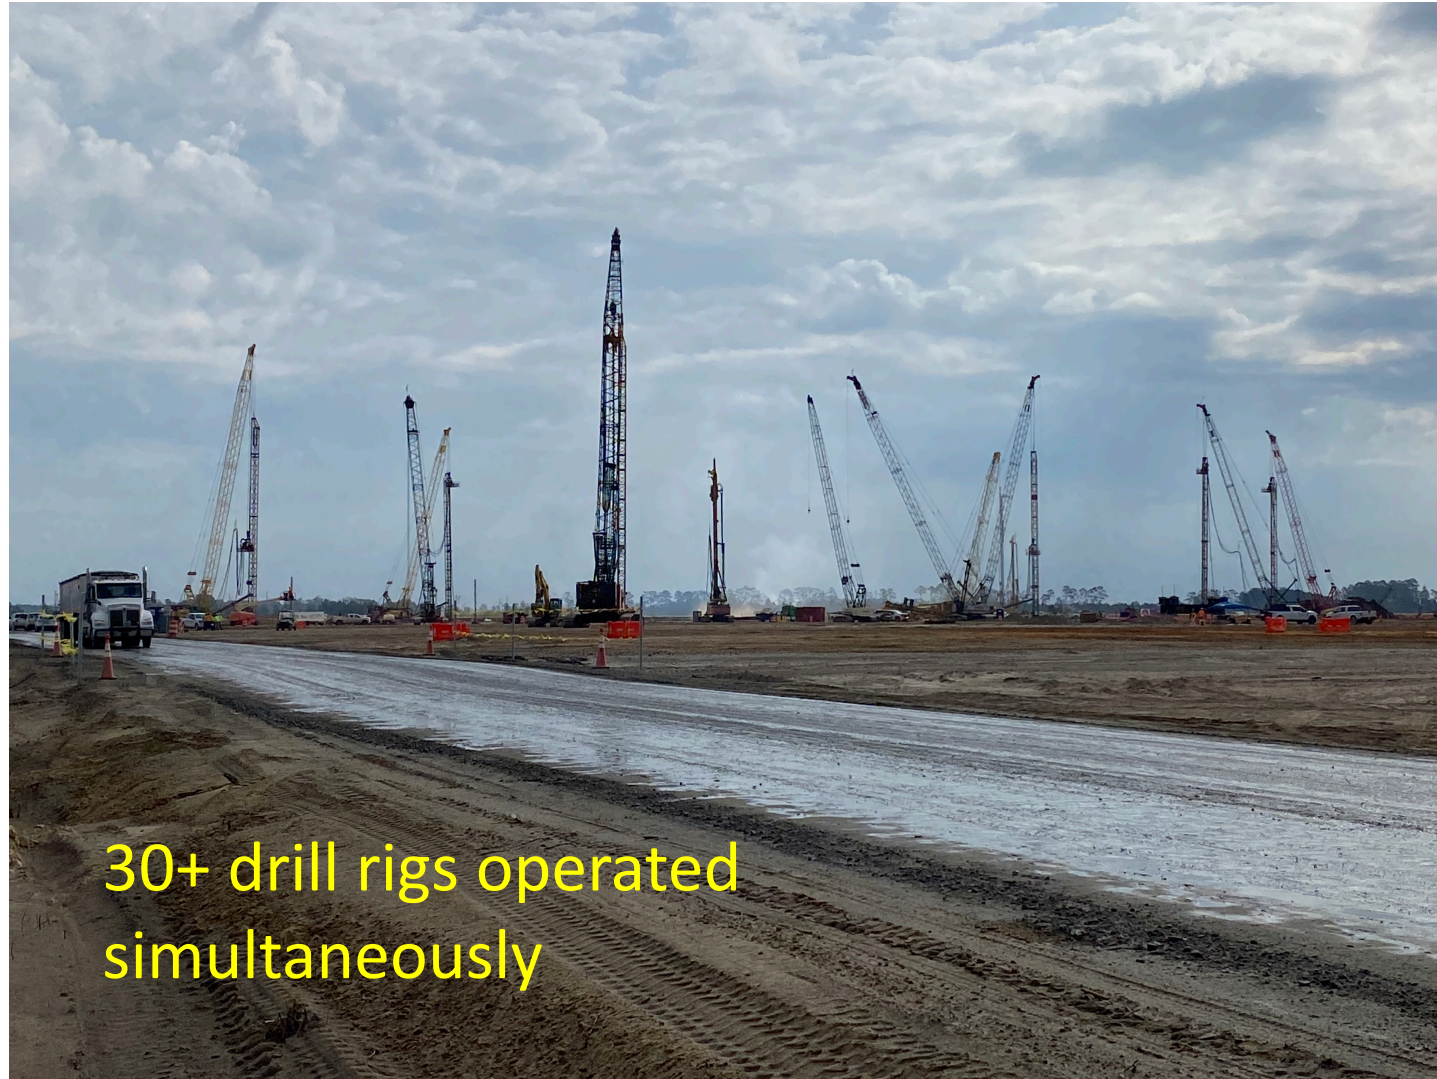
30+ drill rigs operated  
simultaneously

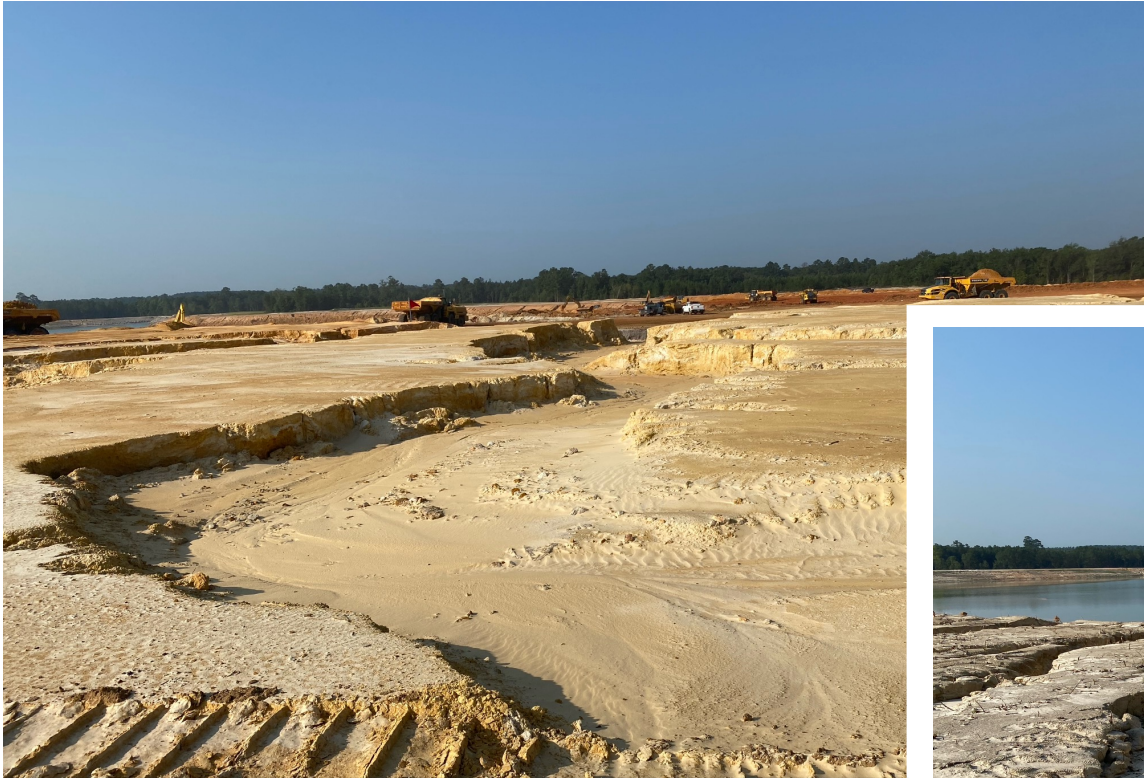
Paint Shop

Groundwater

2,000 AC vast site  
No ditch, No Pond  
Sequence of Construction

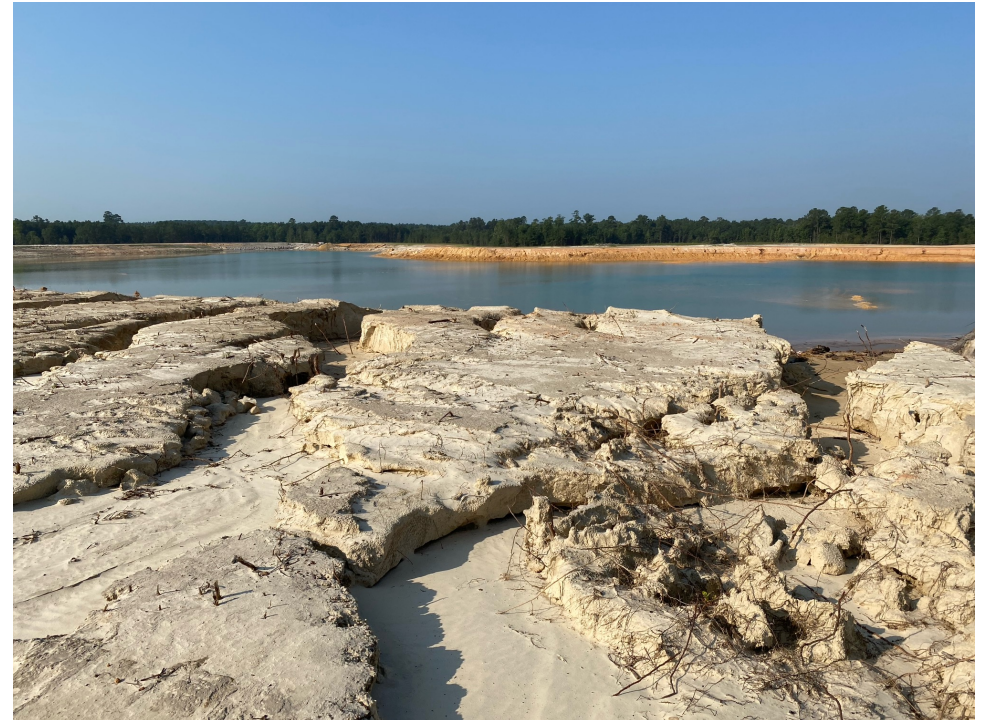
Sandy Soil  
Severe erosion

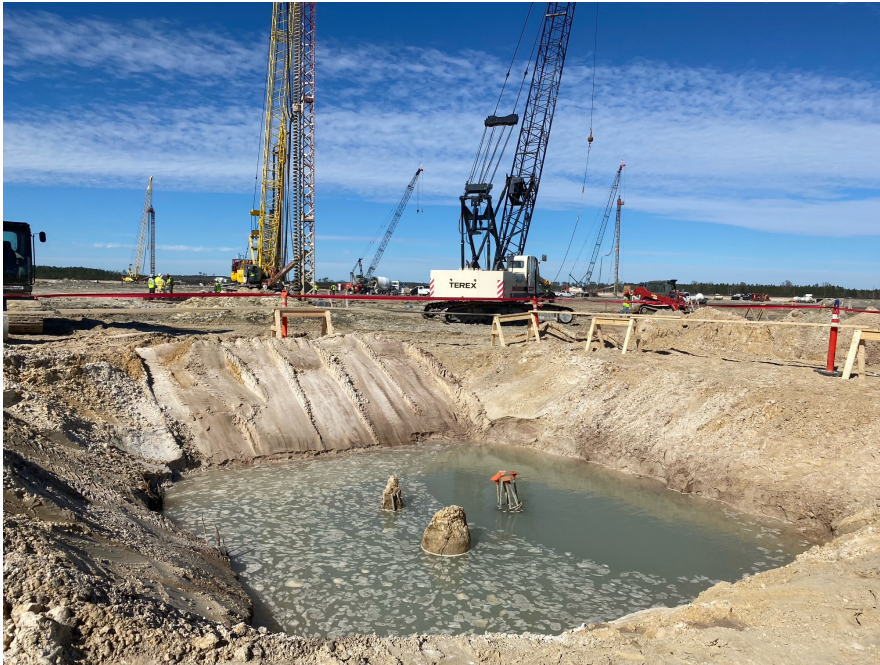
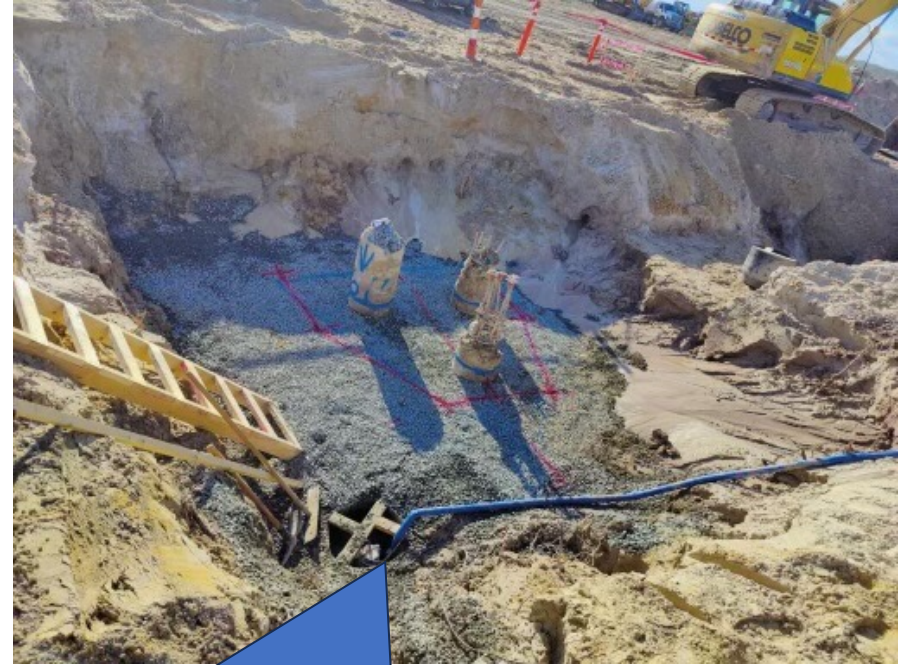
### Pile Cap Excavation

Dewatering in each pile cap

Over-excavate and 12" No. 57 Stone or Flowable Fill

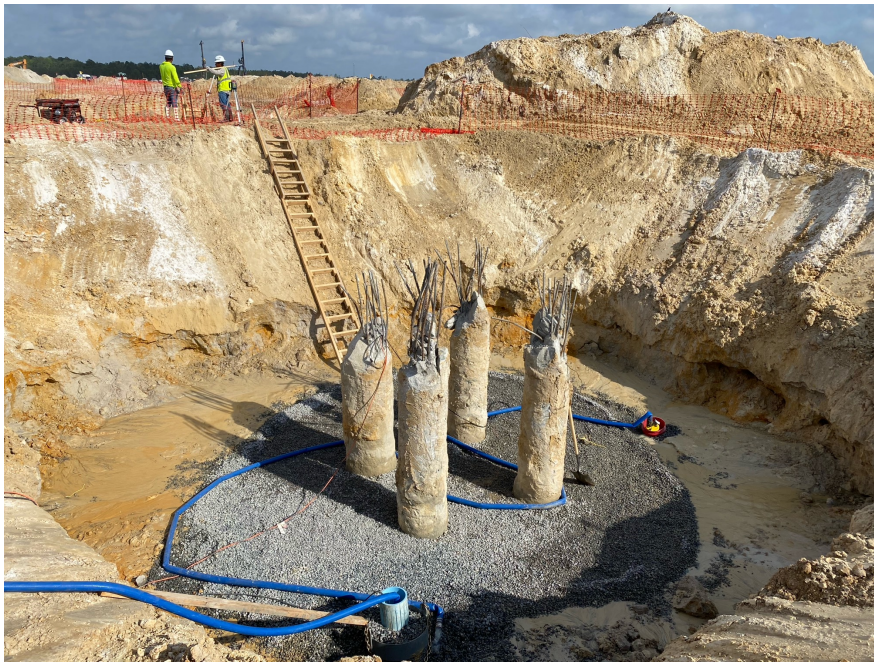
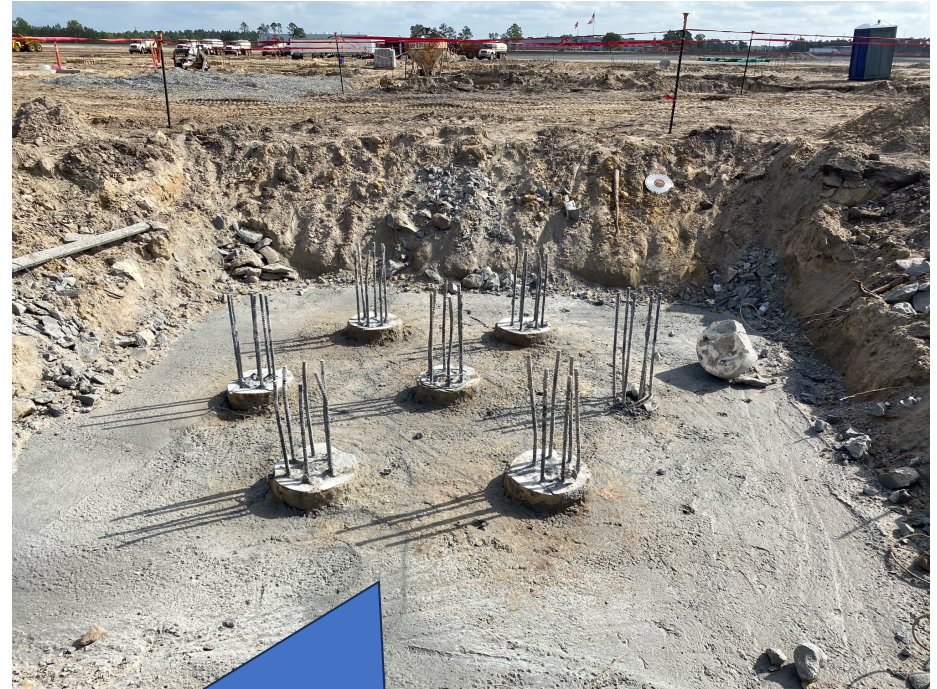
Dewatering and # 57 Stone

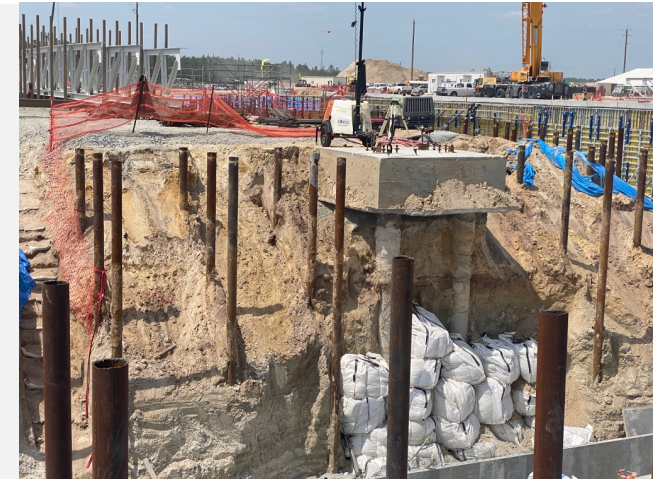
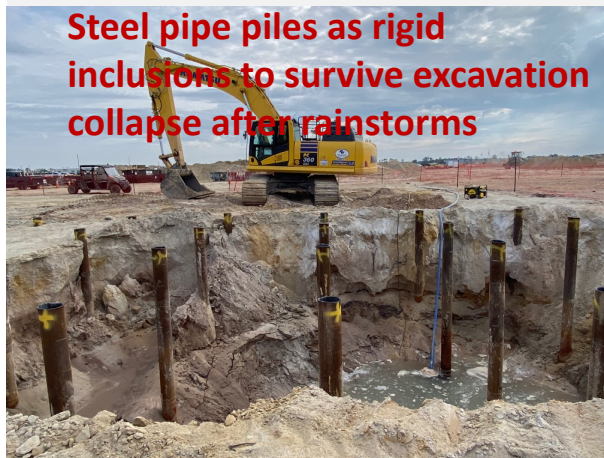
Stamping Plant  
Pits and Tunnels

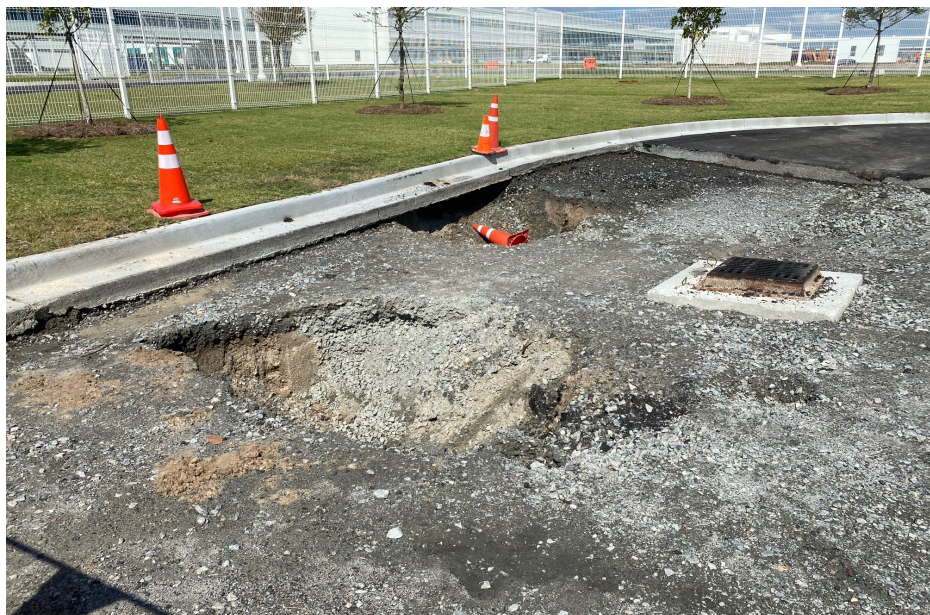
Washout of subgrade soils  
To where?

Likely through open joints in the nearby storm drains

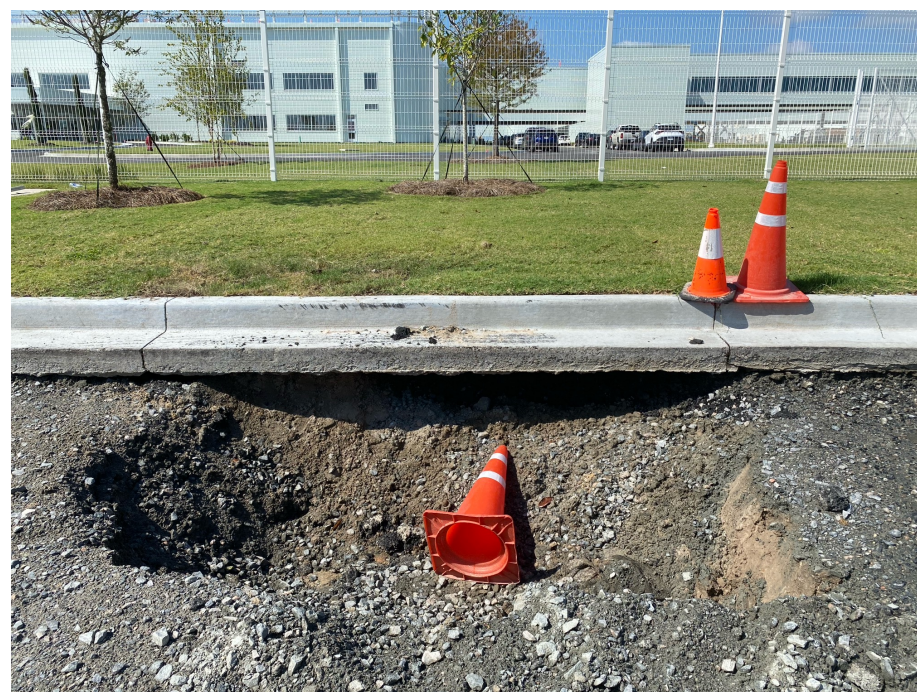
Erosion under pavements  
By Hurricanes Debby (Aug 5, 2024) and Helene (Sept 2024)

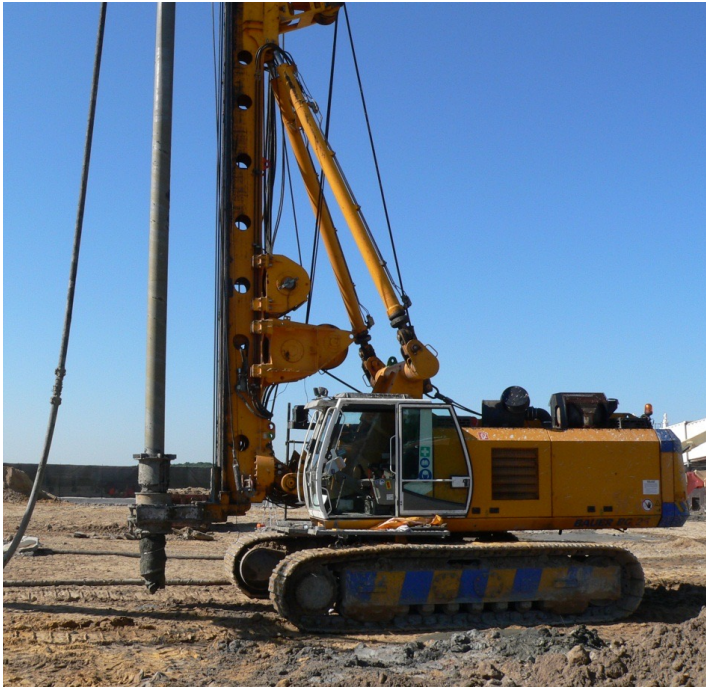
- Displacement auger cast piles
- Push soil lateral to densify sands
- No soil cutting to the surface

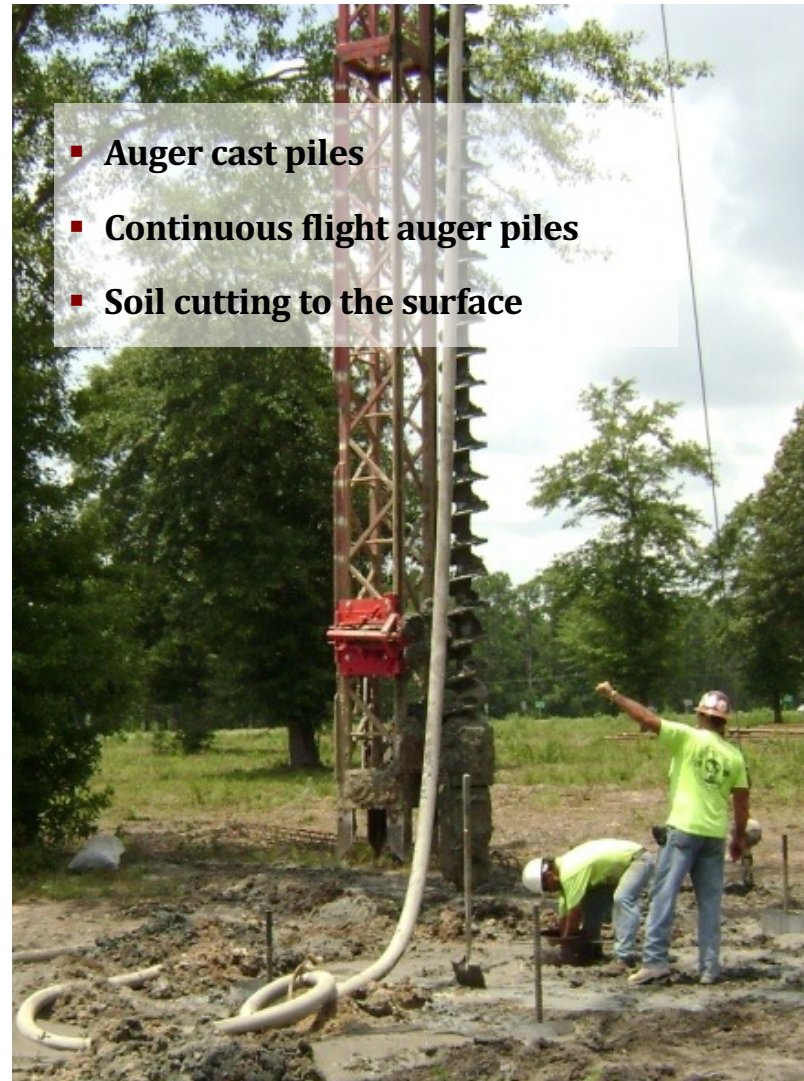
- Auger cast piles
- Continuous flight auger piles
- Soil cutting to the surface
